Fasteners for repairing a chest freezer lid

Some chest freezer lids can form condensation that causes issues, and use odd one-time-use fasteners. This document gives a part number for the hard-to-find replacement fasteners.

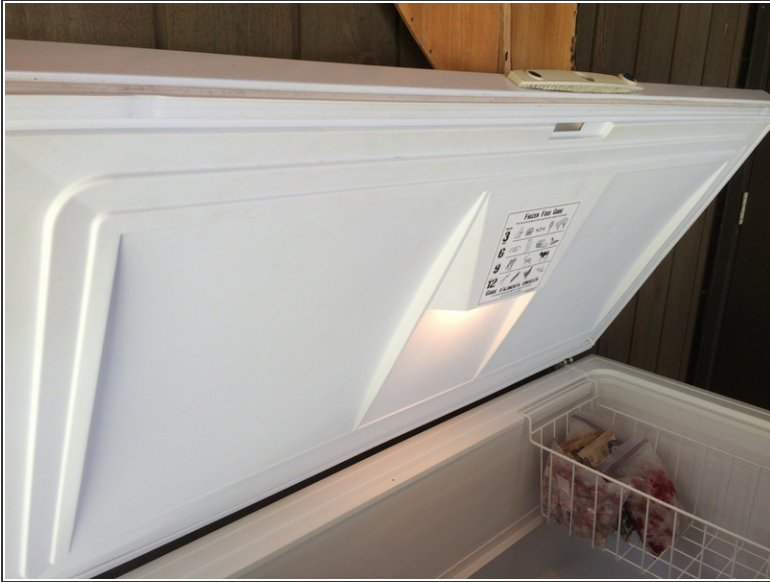
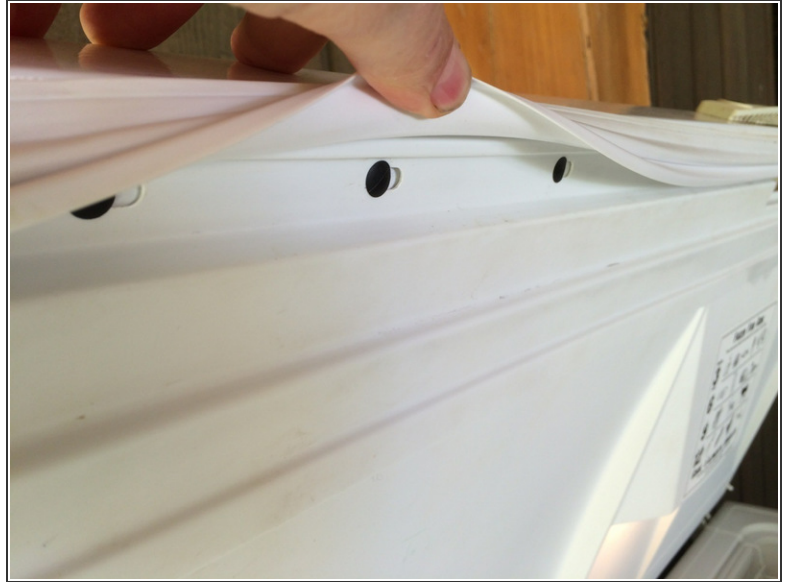
Step 1 — The lid

- The lid is a steel frame around a solid foam panel. The inside of the lid is a thin plastic molded cover held on with plastic push-in retainers (under the gasket). The plastic cover is too thin to be able to use metal screws as a replacement.

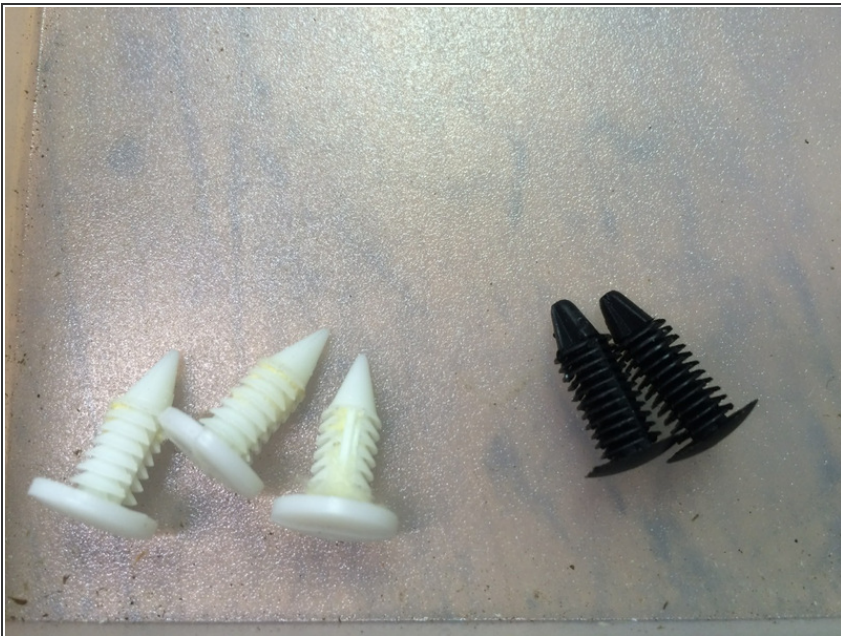
Step 2 — The retainers

- The original retainers (white) and the replacements I found (black). The replacements are AuVeCo #19149: 3/8" head, 7/32" stem width, 5/8" length. Fastenal carries them with SKU 11120582 for a box of 50 (I needed 42).
